Bulletin No. 23

MALAWI
MINISTRY OF NATURAL RESOURCES

GEOLOGICAL SURVEY DEPARTMENT

THE GEOLOGY OF THE SOUTH LILONGWE PLAIN AND DZALANYAMA RANGE

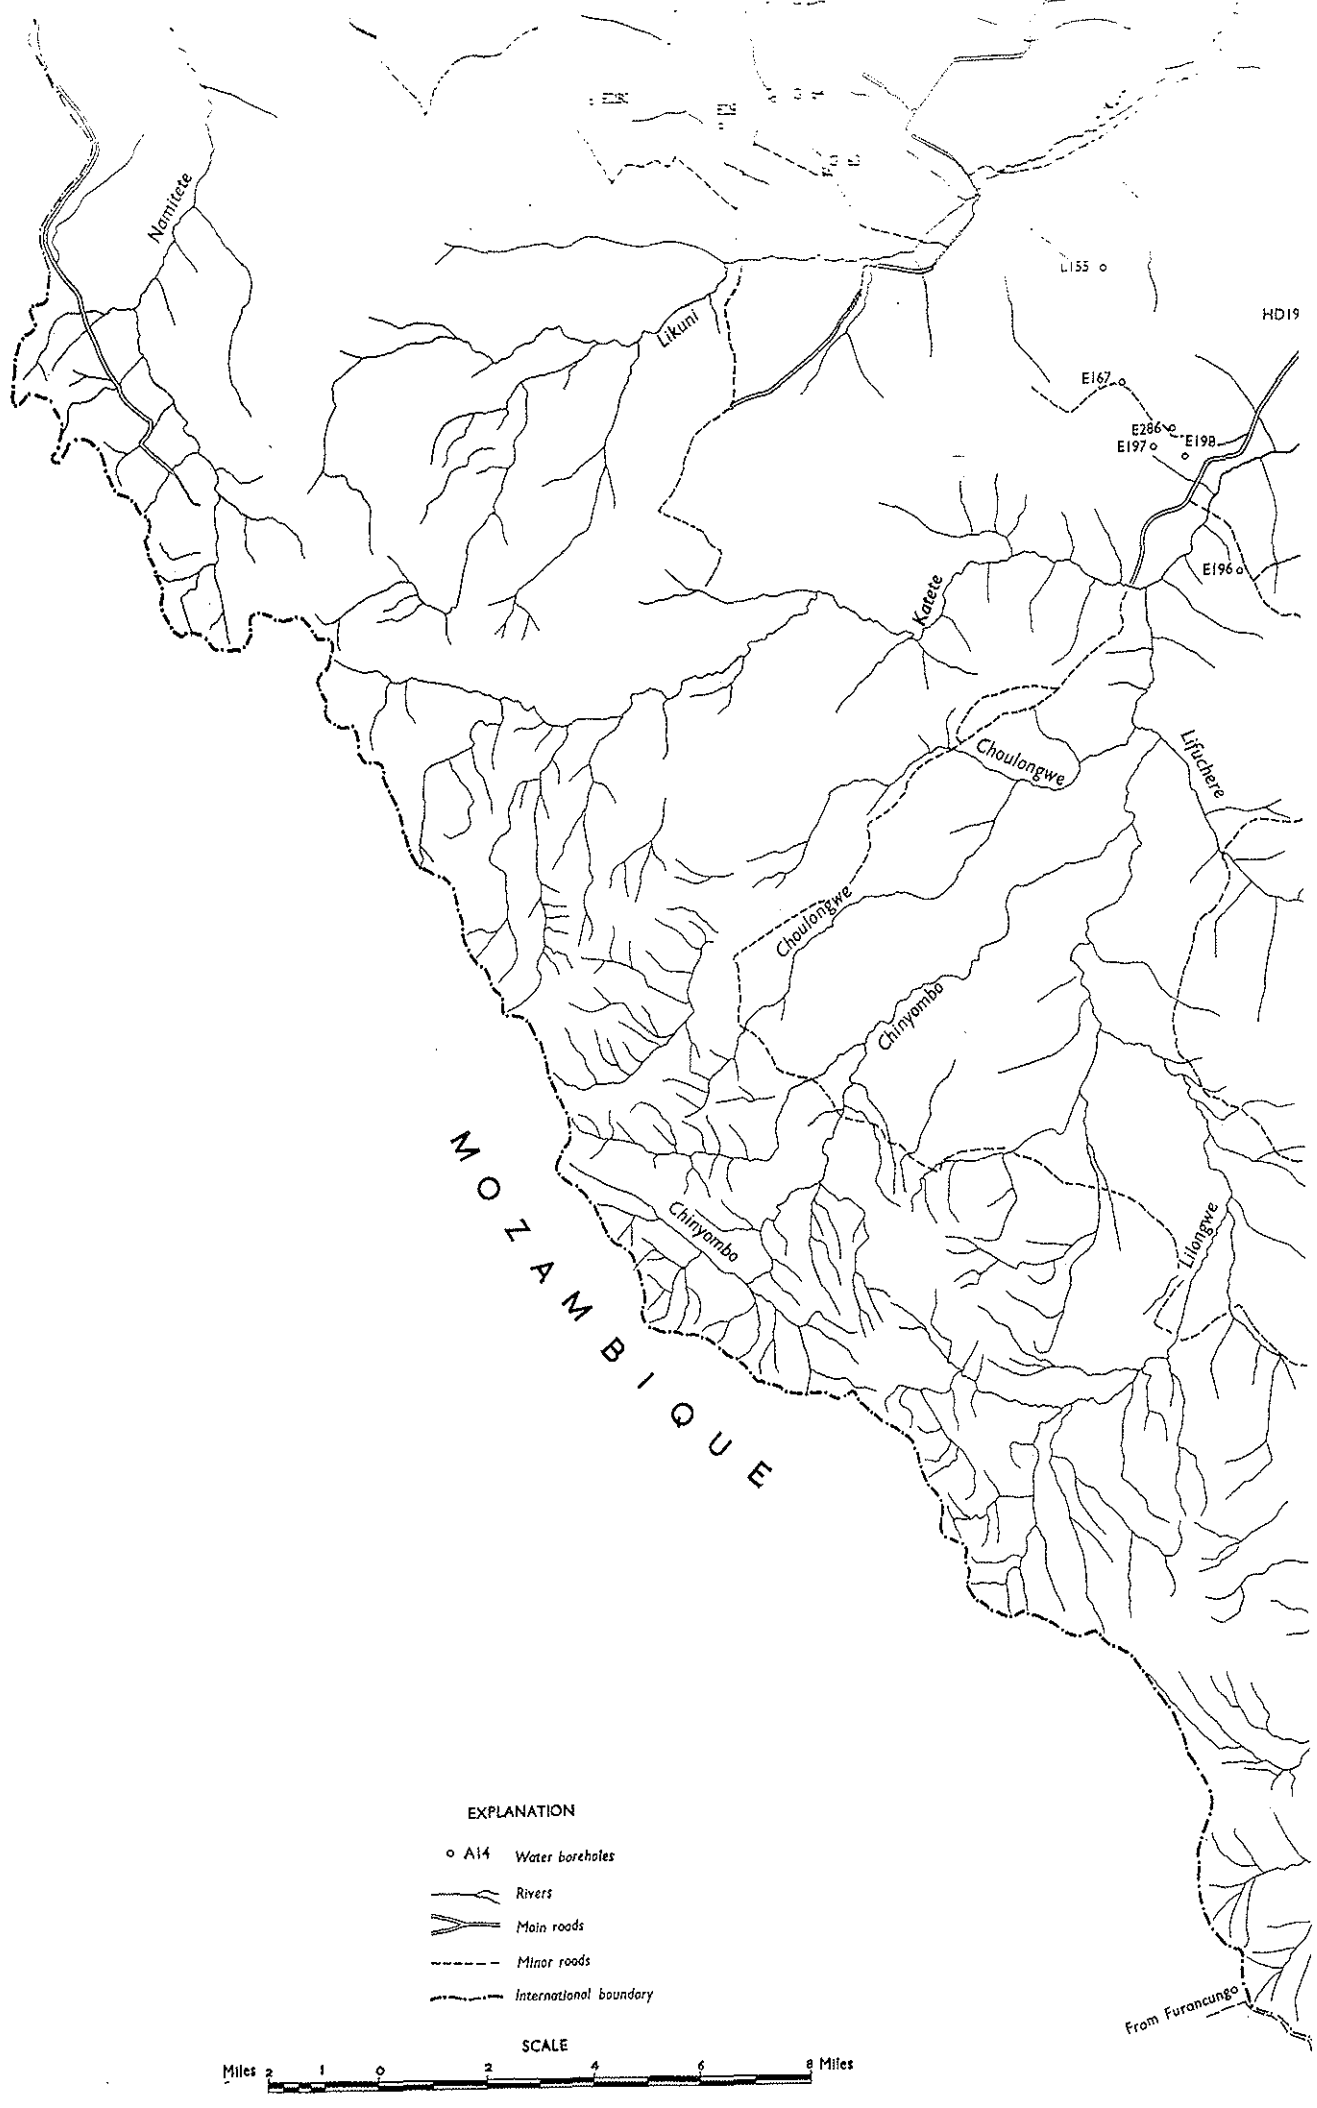
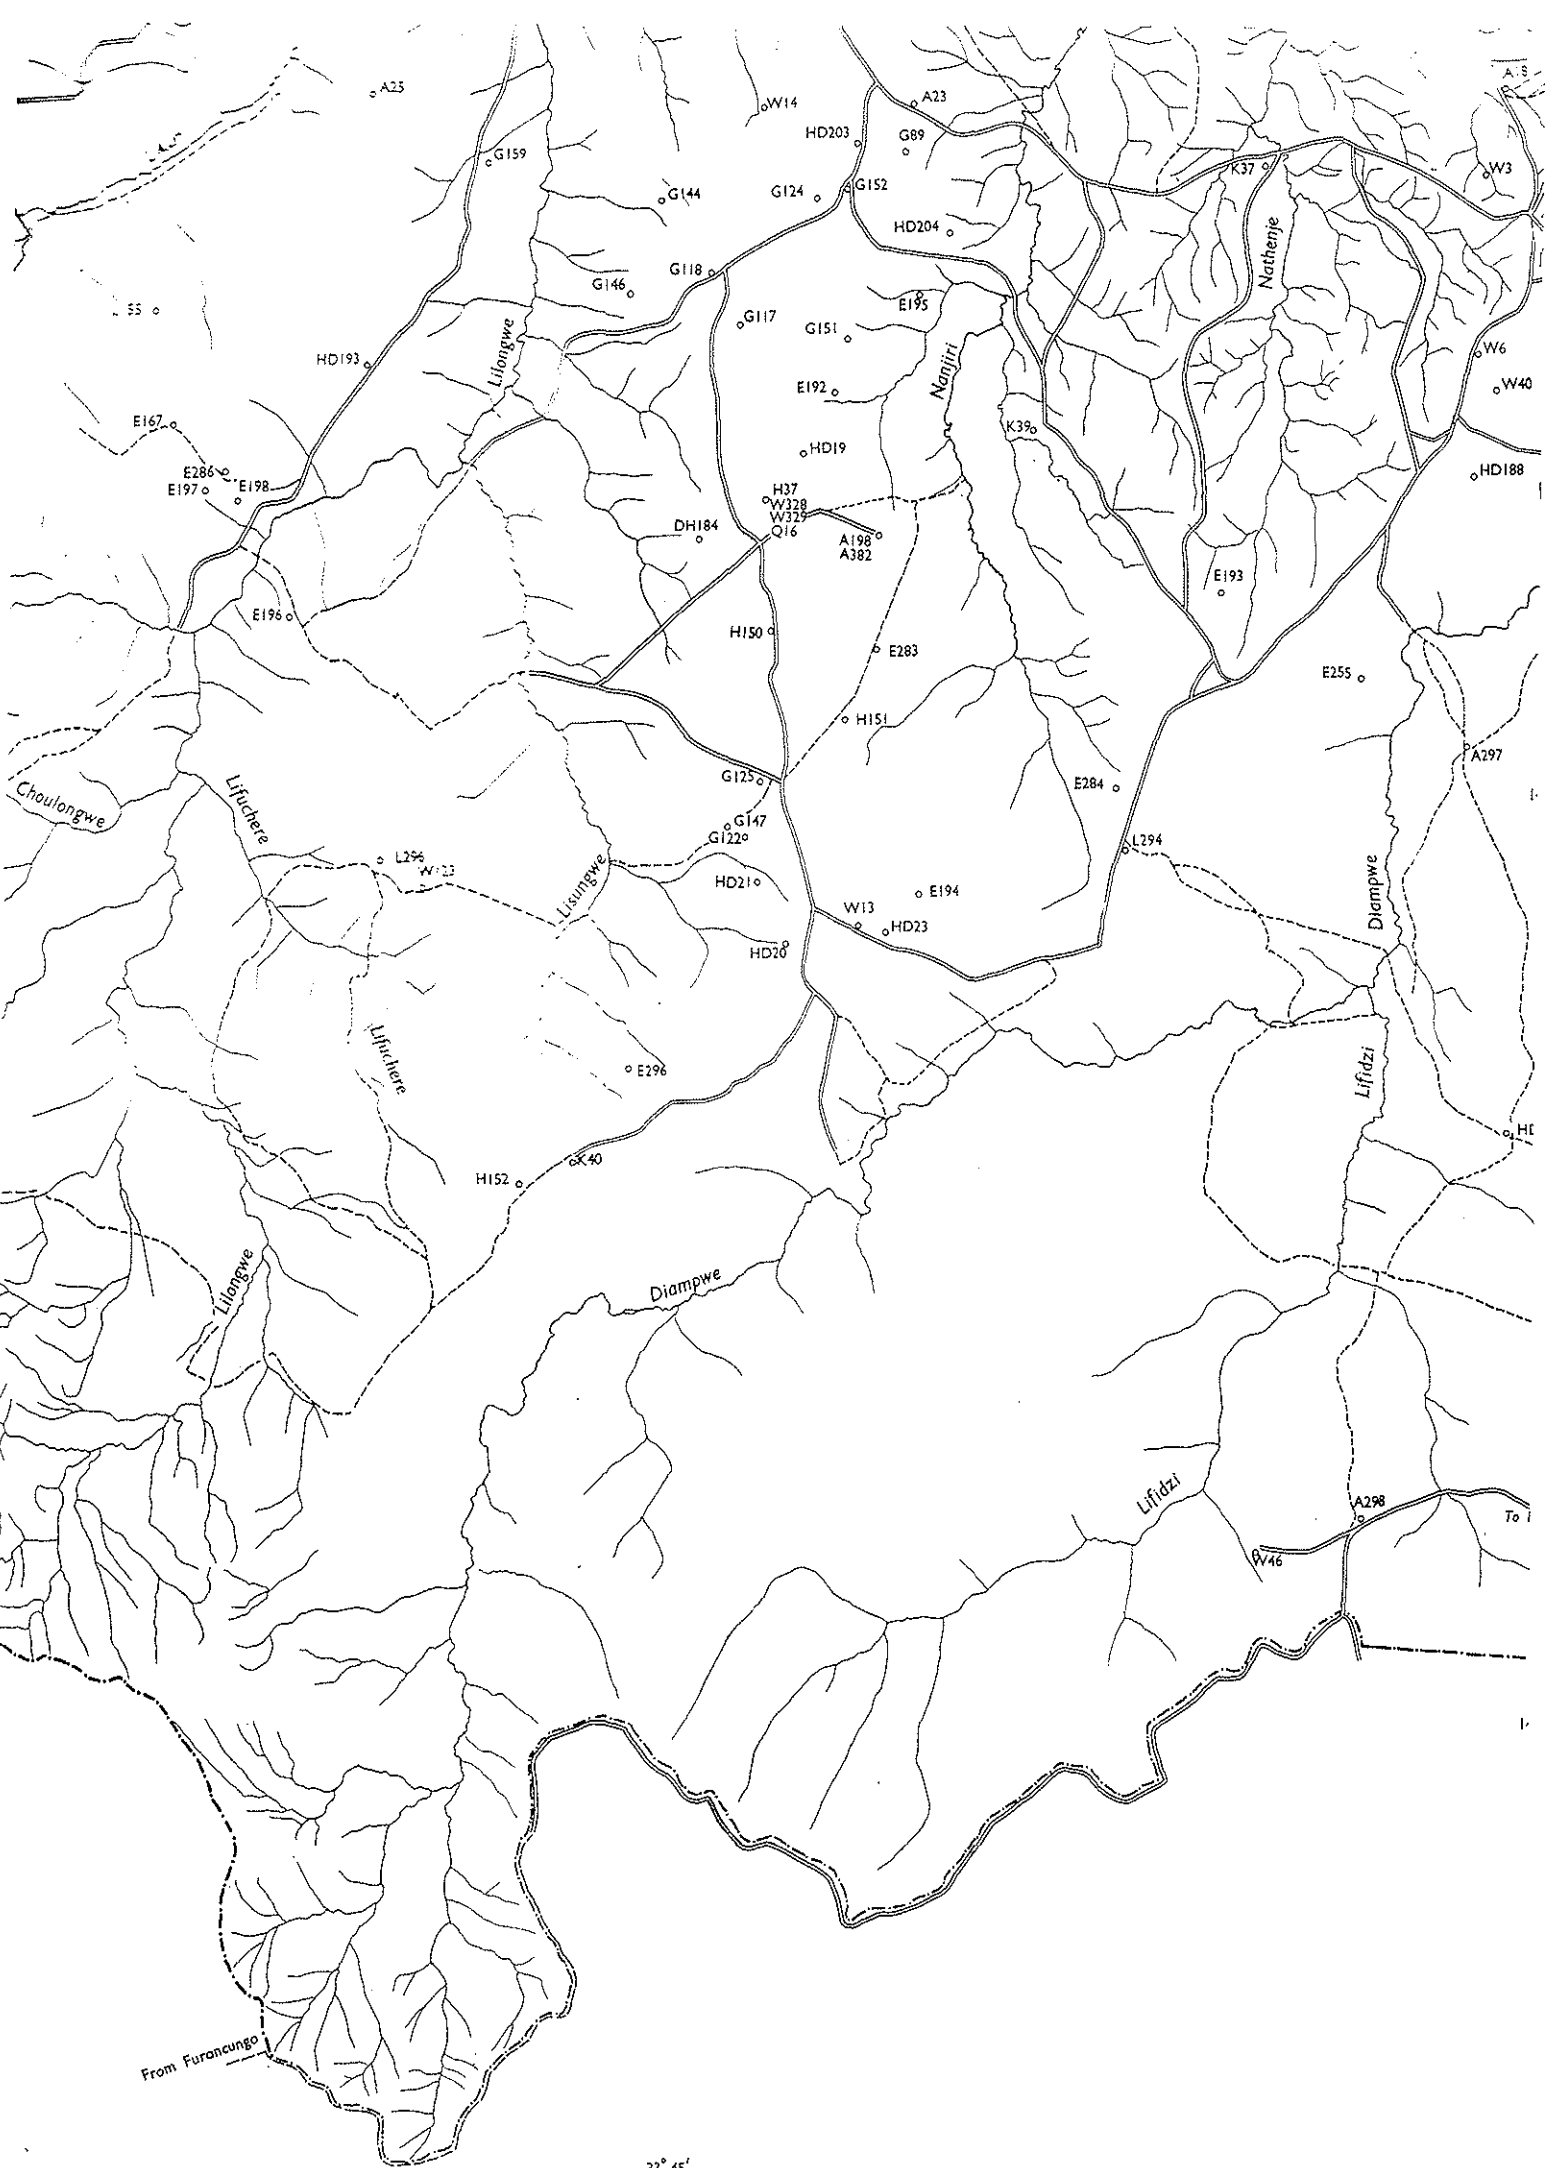
WATER BOREHOLES IN THE SOUTH LILONGWI

Details of the 79 boreholes known to be located in the South Lilongwe Plain area and drilled between 1951 and 1966 are given in Table VI. Others may well exist in this area but their exact location is not known and so they are not recorded here. They were drilled to a mean depth of 115 feet and show measured yields ranging from 120 to 1,500 gallons per hour with a mean of 655 gallons per hour.

The resistivity methods initiated by Cooper (1965) have been used with considerable success on the Lilongwe Plain where the residual deposits of sands and clays are thick. Difficulties have, however, been encountered in areas underlain by thick laterite horizons whose high resistivity tends to mask the underlying aquifers. The anomalously low resistivities associated with bands of graphite-gneiss have not proved dangerously misleading as these rocks almost invariably carry a good supply of water.

Siting of boreholes has proved more difficult in the eastern part of the area where the superficial cover is thin. In spite of this, adequate supplies of water can generally be found within fracture-zones or weathered rocks close to the required point.
